TRANSPORTATION RESEARCH CENTER

ON-SITE AIR BAG INVESTIGATION

CASE NO. - 96-25
FLEET - PRIVATE VEHICLE
LOCATION - MISSISSIPPI
ACCIDENT DATE - 1996

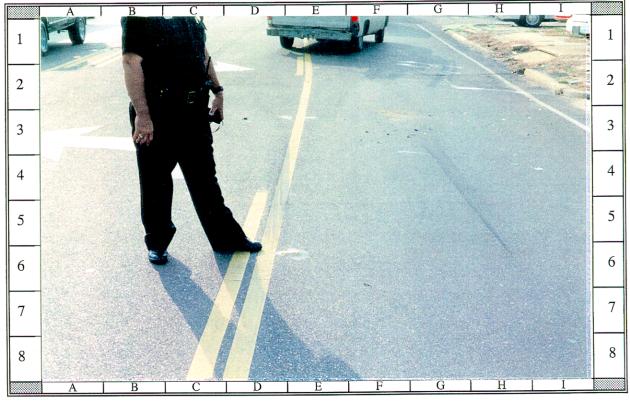
04: On-scene view of Case Vehicle's westward travel path approximately 3 meters (10 feet) from impact; NOTE: left front skidmark starts near road reflector

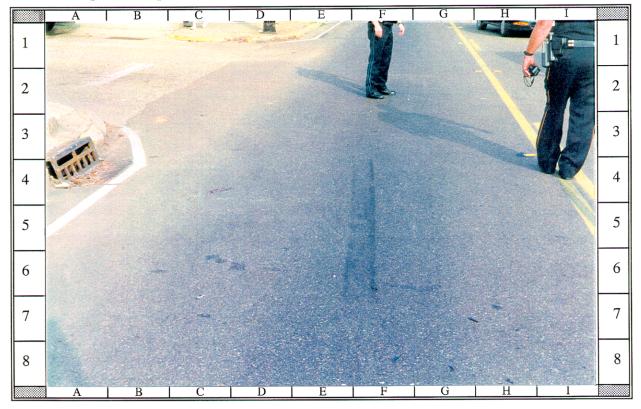
08: On-scene close-up view looking east at right front skidmark deposited by Case Vehicle prior to impact with Vehicle #2

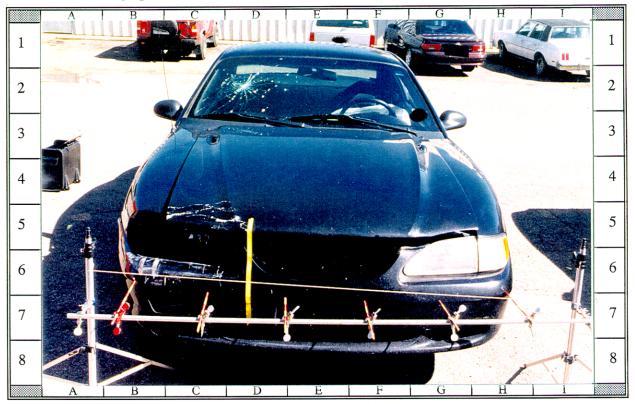
14: Case Vehicle's damaged front with contour gauge present; NOTE: damage left of vertical yellow tape and starred right front windshield (passenger side)

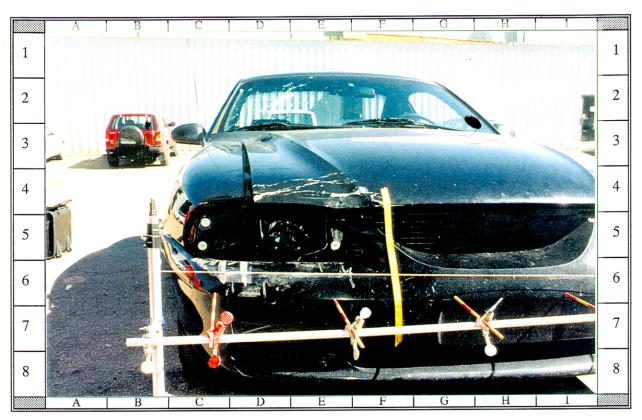
15: Close-up of Case Vehicle's direct frontal damage at bumper level; NOTE: left-ward shift to hood and starred right front windshield

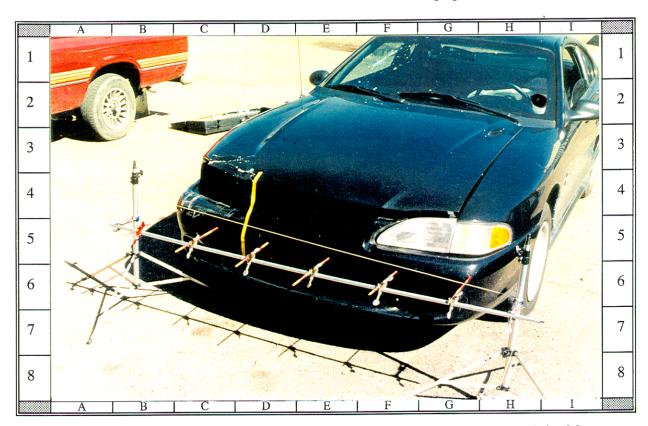
17: Case Vehicle's damaged front viewed from approximately 20 degrees left of front

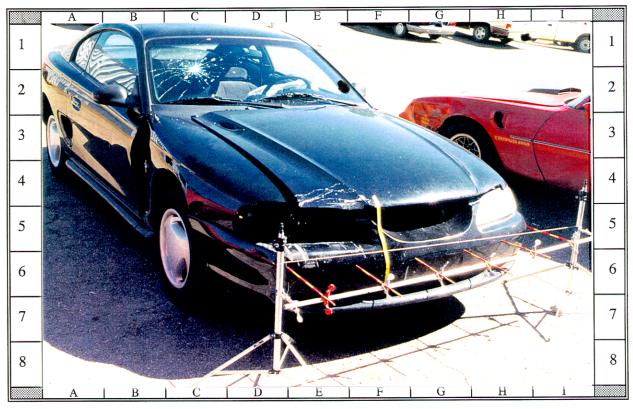
24: Case Vehicle's damaged front viewed from approximately 45 degrees right of front; NOTE: induced damage to right front fender near right front door

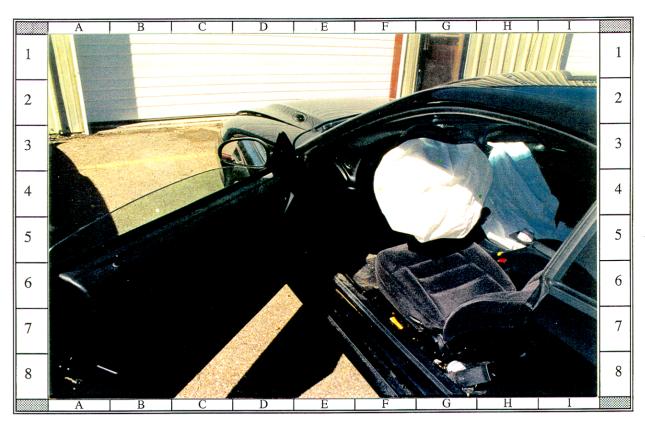
25: Case Vehicle's front seating area showing interior surface of driver's door panel and deployed driver and passenger side air bags

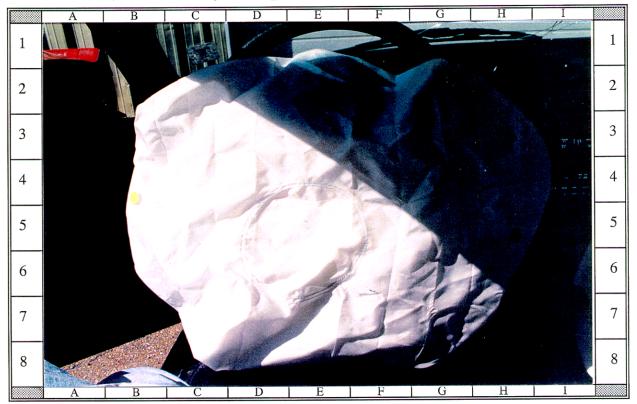
28: Close-up of contact evidence (make-up transfers and mucous--green dots) to upper half of Case Vehicle's driver side air bag; see cells B4, E2, and H5

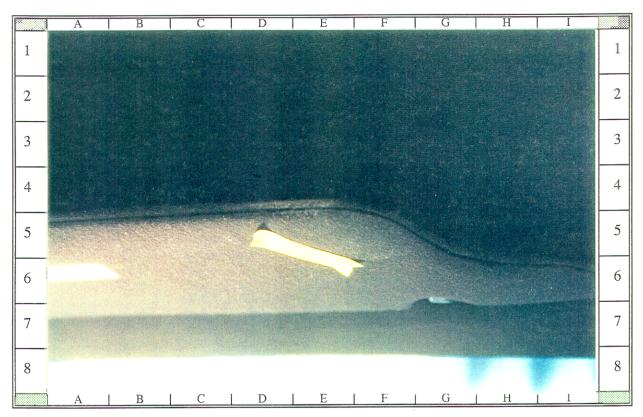
33: Case Vehicle's driver side sunvisor showing generant residue from driver side air bag's vent holes; NOTE: vent holes located at 11:30 and 12:30 positions

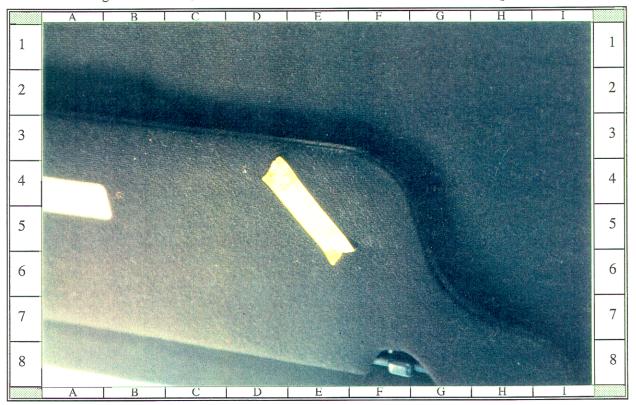
34: Closer-up view of air bag generant residue on corner of Case Vehicle's driver side sunvisor; NOTE: vent holes located at 11:30 and 12:30 positions

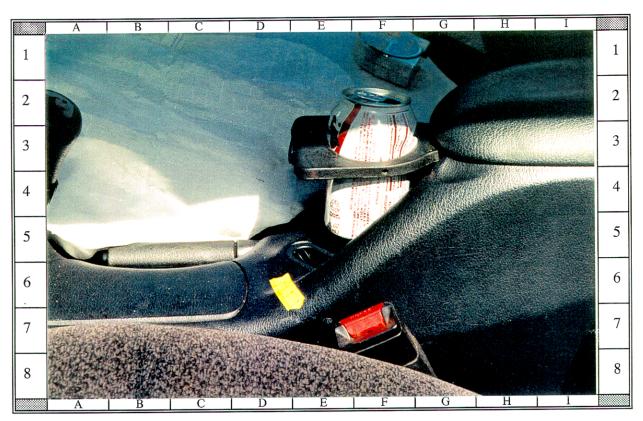
35: Case Vehicle's center console/drink holder showing contact from driver's right forearm; NOTE: tape near blood drop

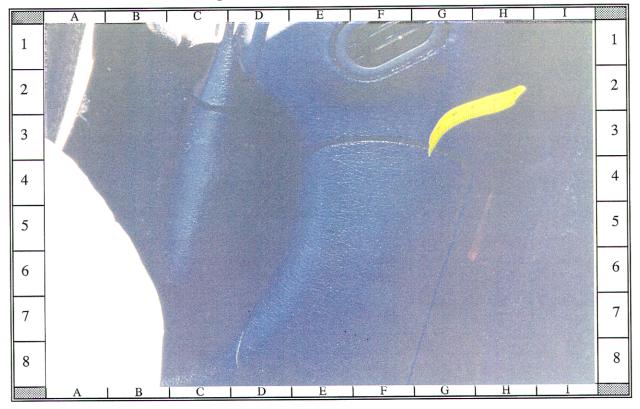
36: Vertical overhead view of blood drops found on Case Vehicle's center console next to parking brake lever

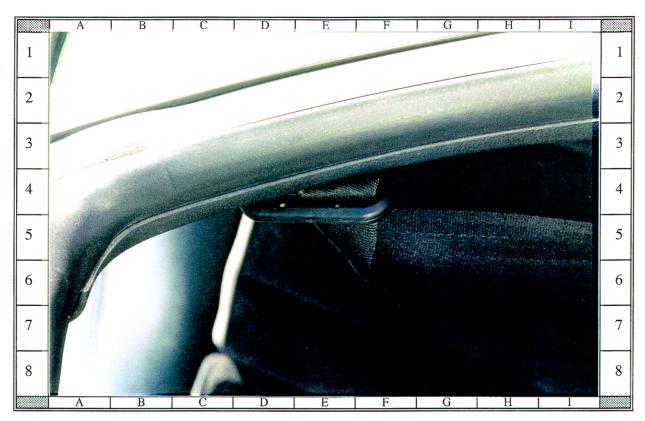
37: Vertical view from outside of "D"-ring from Case Vehicle's driver side seat belt showing evidence of loading

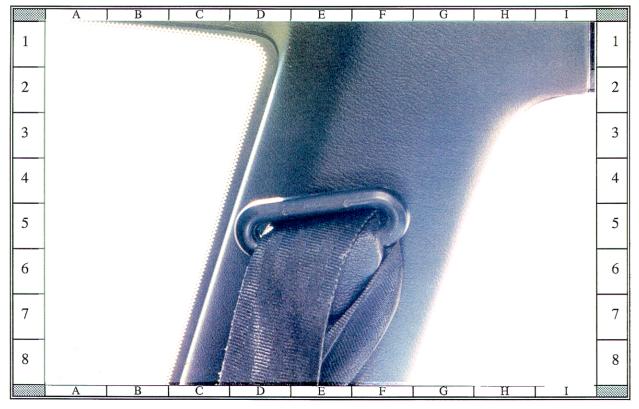
38: "D"-ring from Case Vehicle's driver side seat belt viewed from center front showing evidence of loading

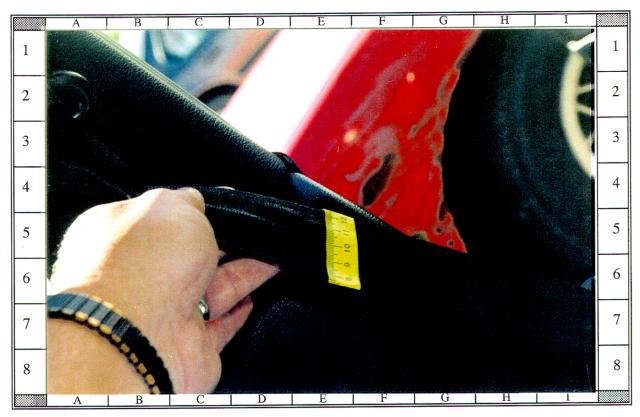
39: Vertical close-up of Case Vehicle's driver side seatbelt webbing showing only storage mark near yellow tape

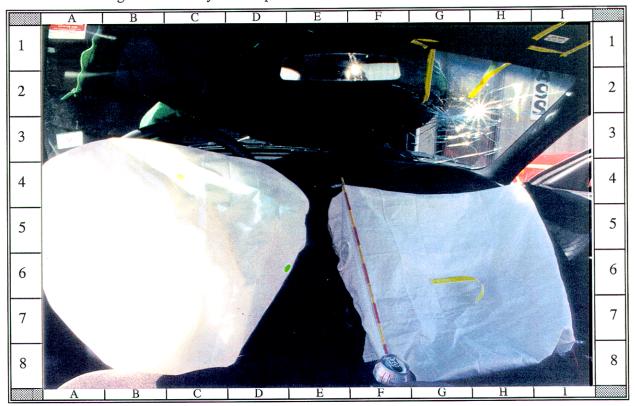
40: Panoramic view of Case Vehicle's deployed air bags; NOTE: contacts to right front (passenger side) windshield and sunvisor/roof

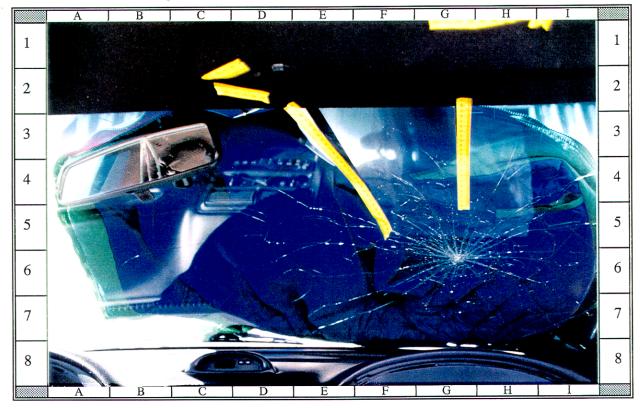
42: Close-up of Case Vehicle's right front windshield showing head contact; NOTE: rearview mirror and left corner of sunvisor were contacted by air bag

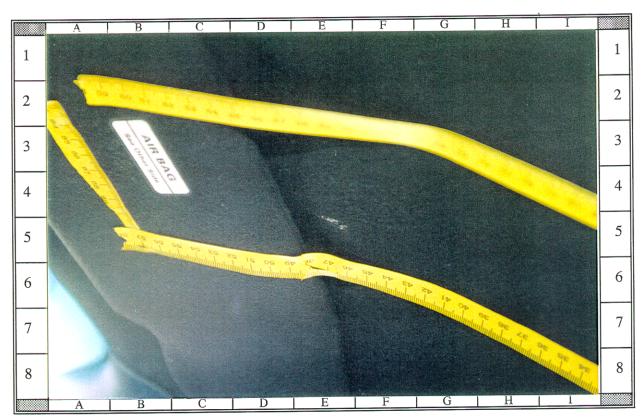
47: Close-up of Case Vehicle's right front roof area showing contacted sunvisor and probable skin transfer to roof made by right front passenger

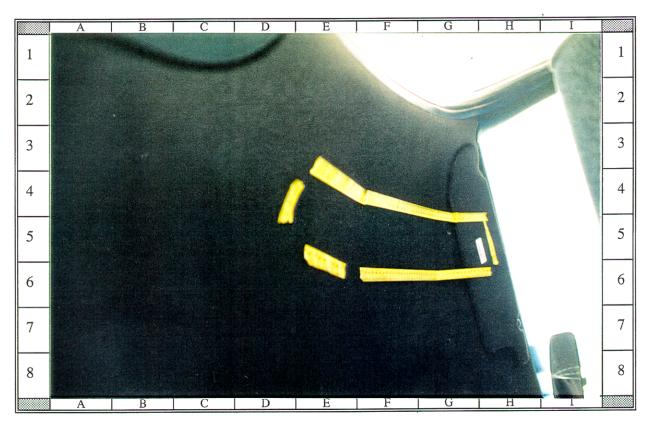
49: Vertical view of Case Vehicle's right front roof area from right rear seat showing roof contacts

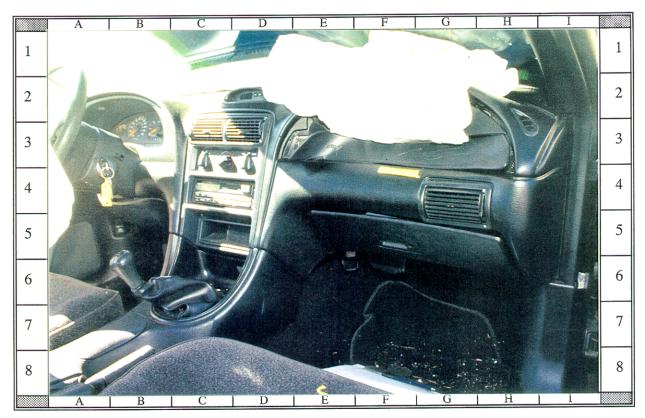
55: Case Vehicle's center and right front dash; NOTE: possible contact just above glovebox and below tape

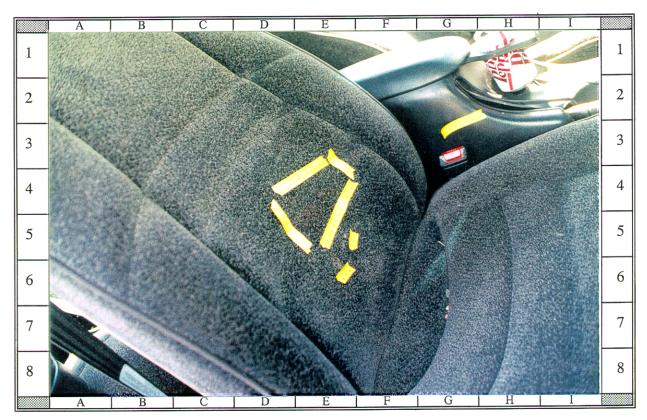
Given the significant blood stains on the right front passenger's seat and the right side of the center console (see SELECTED PHOTOGRAPHS #57 and #58), it is noteworthy that there was no blood present on the seatbelt (see SELECTED PHOTOGRAPH #65).

57: Dried blood stain on Case Vehicle's right front seatback from right front passenger

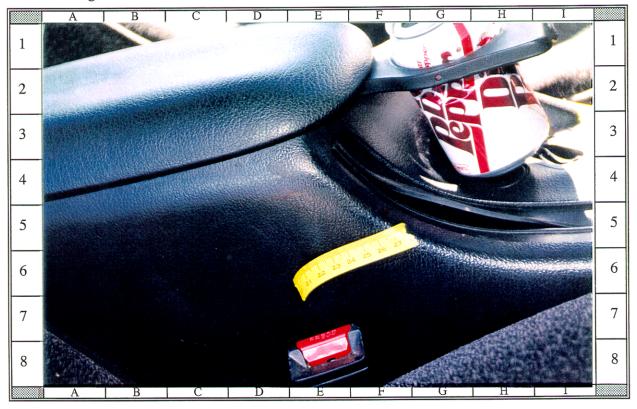
58: Blood smear (above tape) to passenger side of Case Vehicle's floor mounted center console

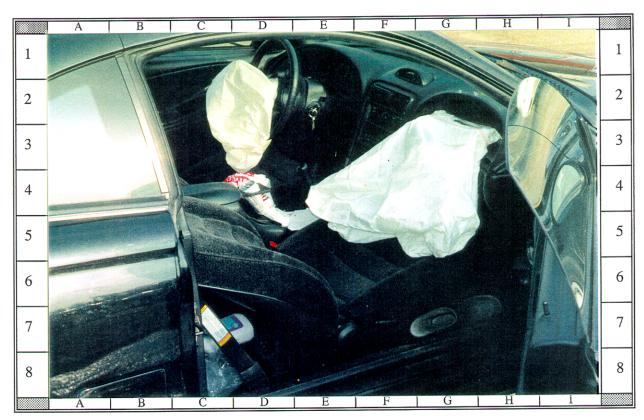
59: On-scene view of Case Vehicle's right front passenger seating area showing deployed driver and passenger side air bags; NOTE: passenger's seat reclined

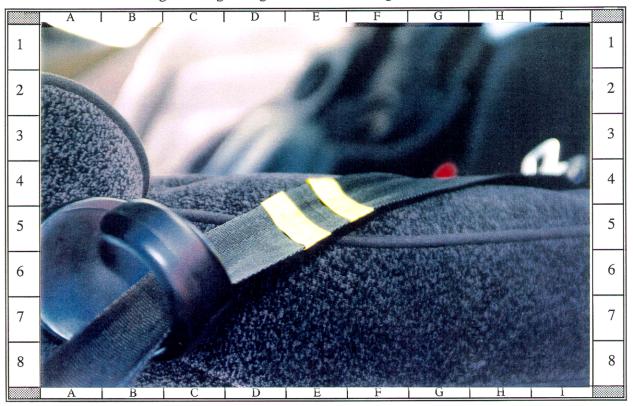
64: Case Vehicle's right front passenger side seatbelt webbing showing storage crease (between tape) in webbing

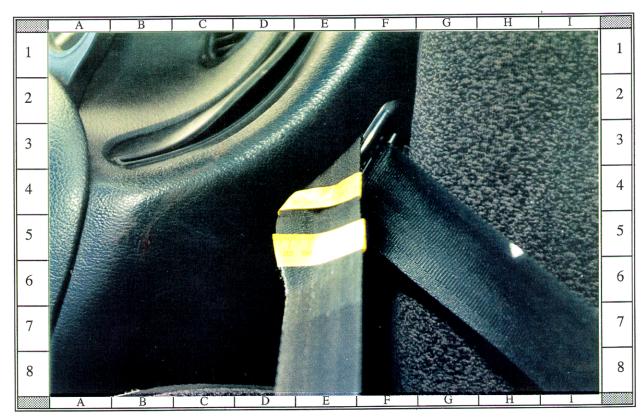
65: Vertical view of storage crease in Case Vehicle's right front passenger side seatbelt webbing; NOTE: no evidence of blood on webbing when latched

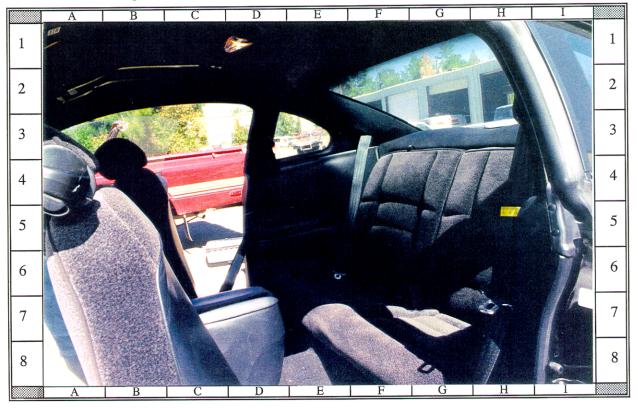
68: Case Vehicle's rear seating area showing right rear seat where passenger was seated; NOTE: three-point belts and integral head restraints in outboard seats

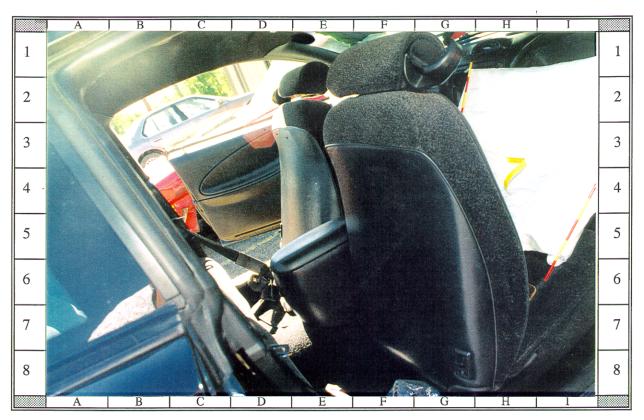
contacts were found to the rear of the right front passenger's seatback (see SELECTED PHOTO-GRAPH #69), and he did not sustain any injuries or received any treatment.

69: Case Vehicle's right front passenger seatback showing no evidence of contact from right rear passenger

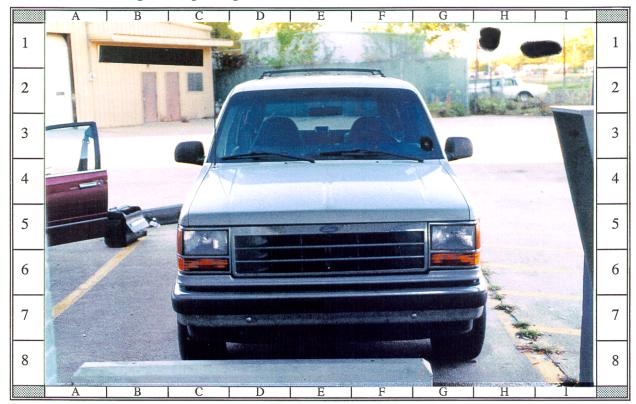
70: 1991 Ford Explorer XL's undamaged front

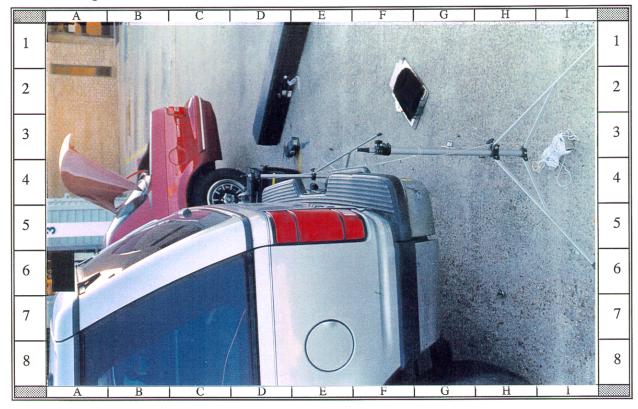
72: Vertical reference line view of Vehicle #2's contacted rear bumper from left; NOTE: minimal deformation

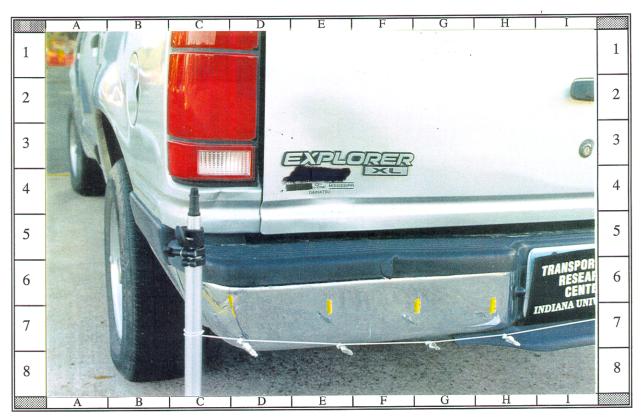
75: Close-up of Vehicle #2's damaged back left corner viewed from approximately 10 degrees left of back; NOTE: only four C-measurements taken

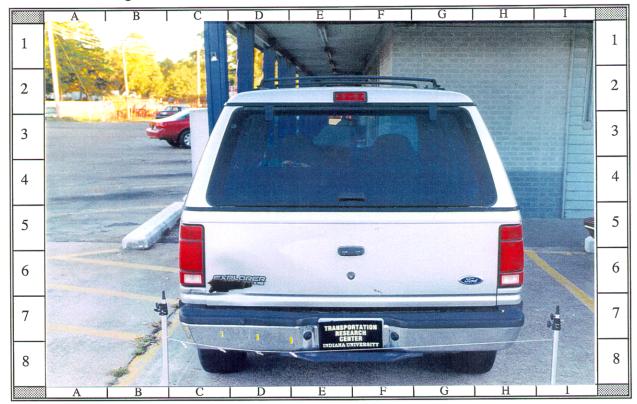
76: Vehicle #2's damaged back; NOTE: length of damage confined to back left (i.e., yellow tape)

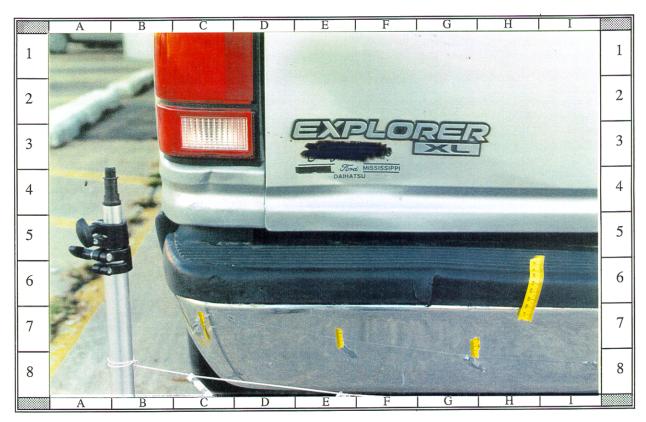
77: Straight on closer-up view of Vehicle #2's damaged back left corner

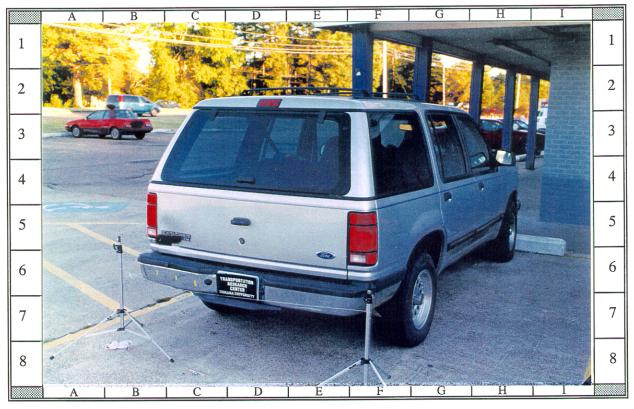
78: Vehicle #2's damaged back and undamaged right side viewed from approximately 15 degrees right of back

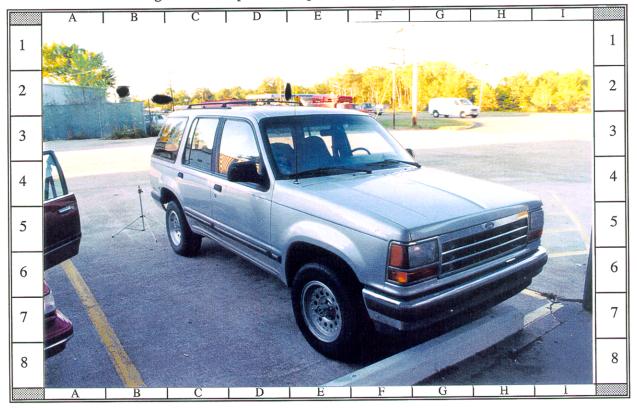
80: Vehicle #2's undamaged right side and front viewed from approximately 45 degrees right of front

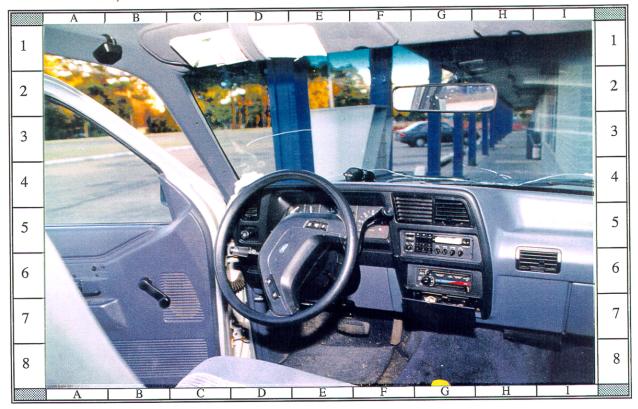
82: Panoramic view of Vehicle #2's driver side greenhouse area, steering wheel, and dash; NOTE: no evidence of loading, but cracked windshield is previous damage

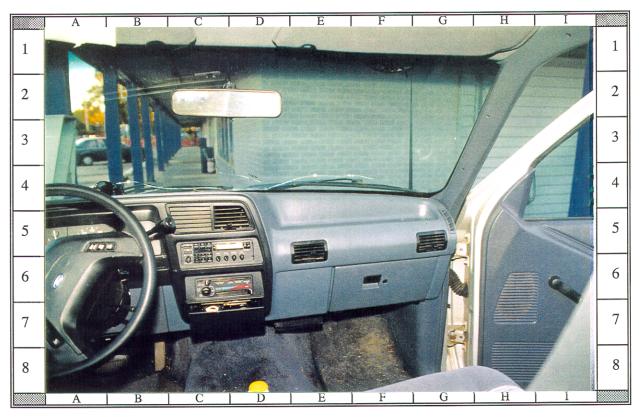
83: Panoramic view of Vehicle #2's right front passenger side greenhouse area and dash; NOTE: no evidence of loading, but cracked windshield is previous damage

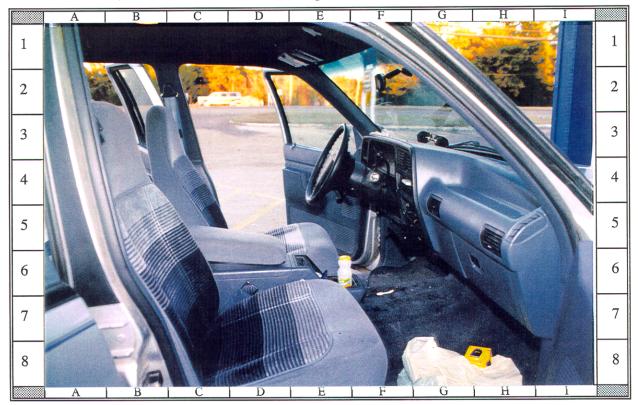
84: Vehicle #2's front seating area and front dash viewed from outside right front passenger door

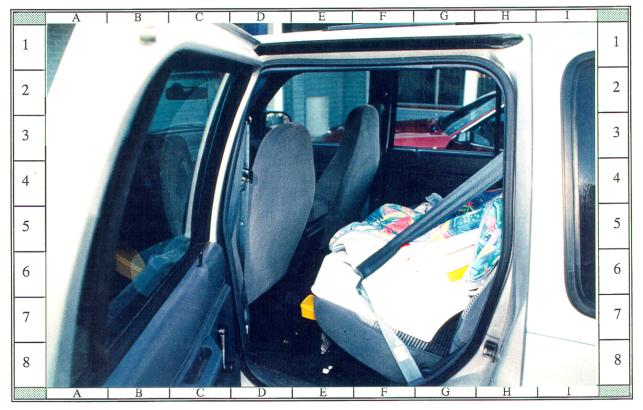
86: Vehicle #2's rear seating area from left; NOTE: child safety seat located in center rear position at time of crash and no evidence of loading to driver's seatback

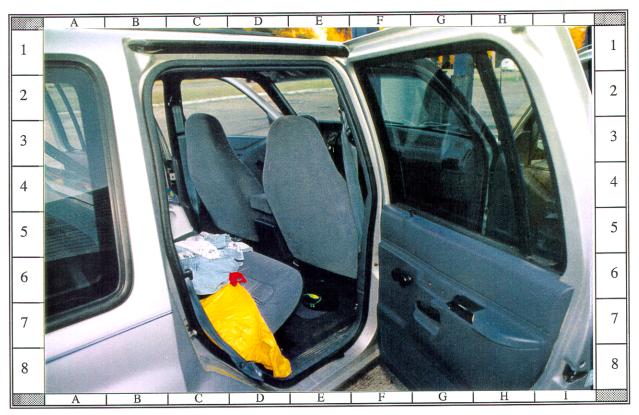
87: Interior surface of Vehicle #2's right rear door panel and right rear seating area from right; NOTE: no evidence of loading to right front passenger's seatback
